STREAM RESTORATION PLAN

PADUA STABLES PROJECT FAYETTE COUNTY, KENTUCKY

**Redwing Ecological Services, Inc.
Louisville, Kentucky**

November 5, 2009

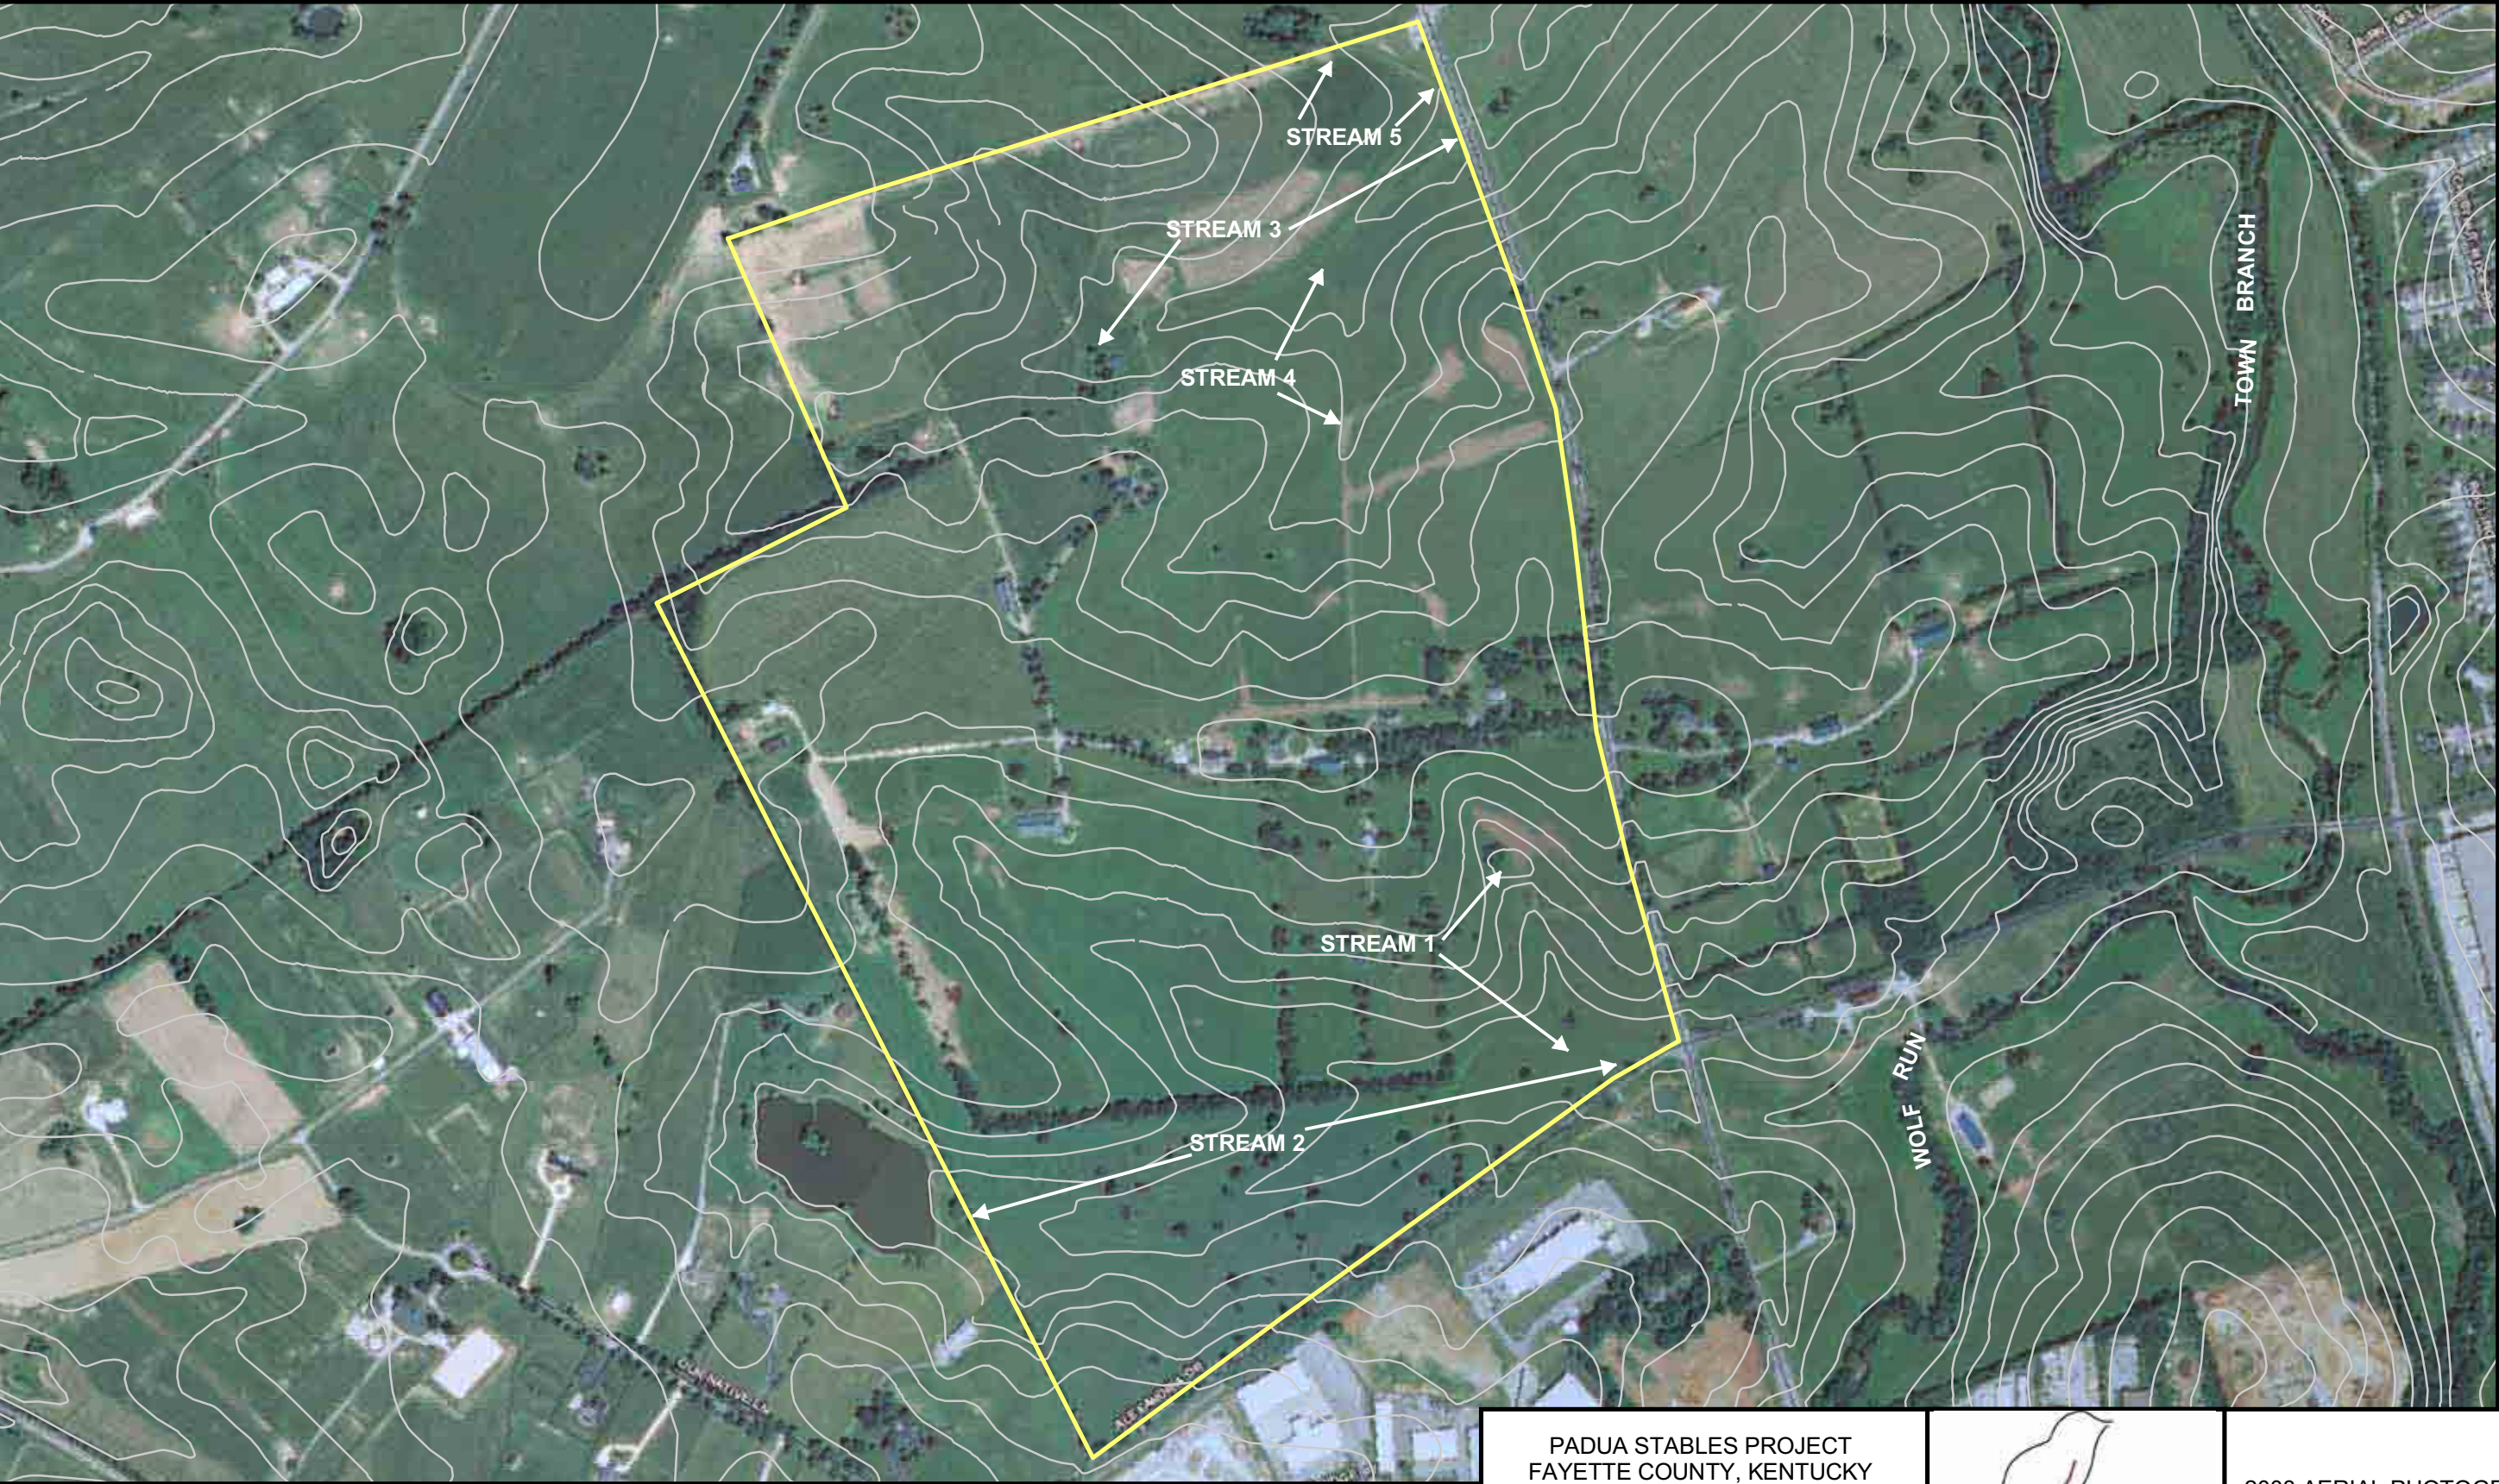
FIGURE 7

2008 AERIAL PHOTOGRAPH

In 2008, the on-site drainages were piped and covered with soil in preparation for horse grazing (Figure 7). The piping and grading was performed for all areas within proposed pastures including those with defined streams and those without defined features. Following these activities, the KDOW issued a Notice of Violation to Three Chimneys Farms, and all work in these areas was stopped. Installation of the drainage pipes was not completed, which has resulted in overland surface flow in the larger watersheds of Streams 2 and 3. Currently, there are no defined surface channels, and the drainage areas are dominated by a mixture of upland and wetland herbaceous species.

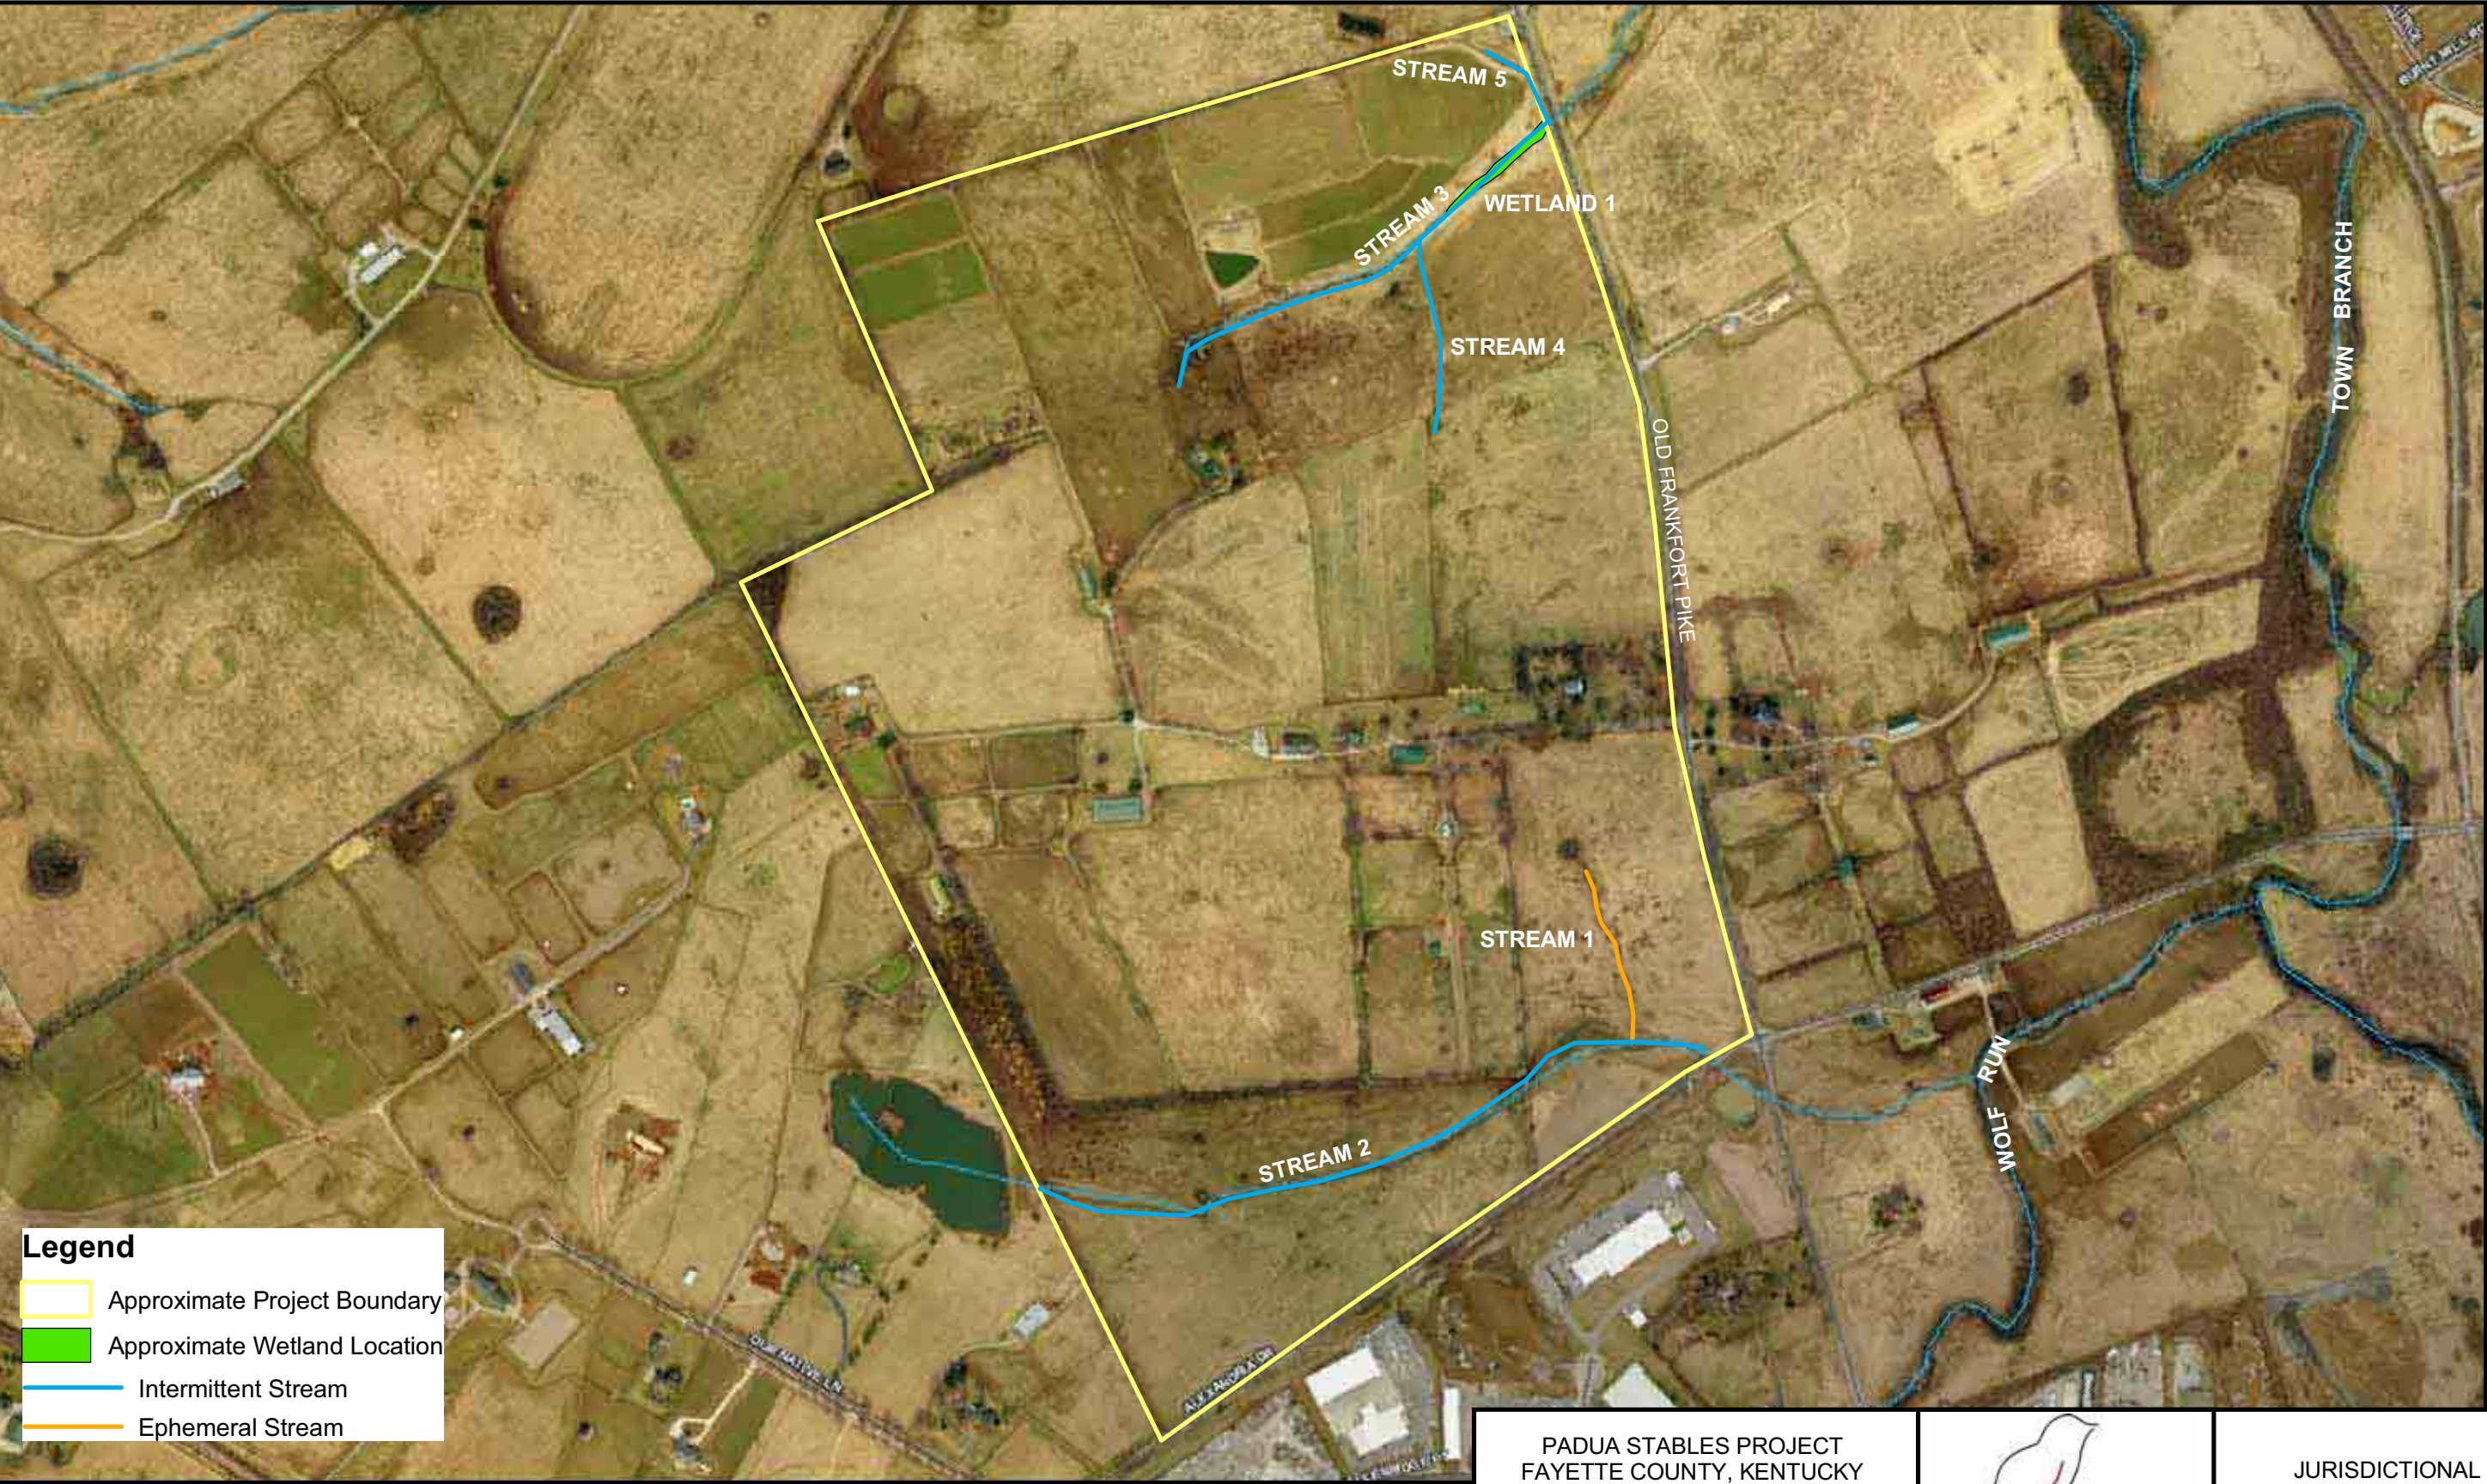
FIGURE 8

JURISDICTIONAL
DETERMINATION MAP

The USACE performed a site visit in May 2009 to determine the jurisdiction extent of streams on the property. The jurisdictional determination was based on the soil survey, historic aerials, and conditions in the field. The following table summarizes the on-site jurisdictional streams. The location of each stream is presented on Figure 8.

An approximately 0.33-acre wetland is located at the downstream end of Stream 3. This area has not been delineated and has not been impacted by grading or piping activities. The approximate location of this feature is shown on Figure 8.

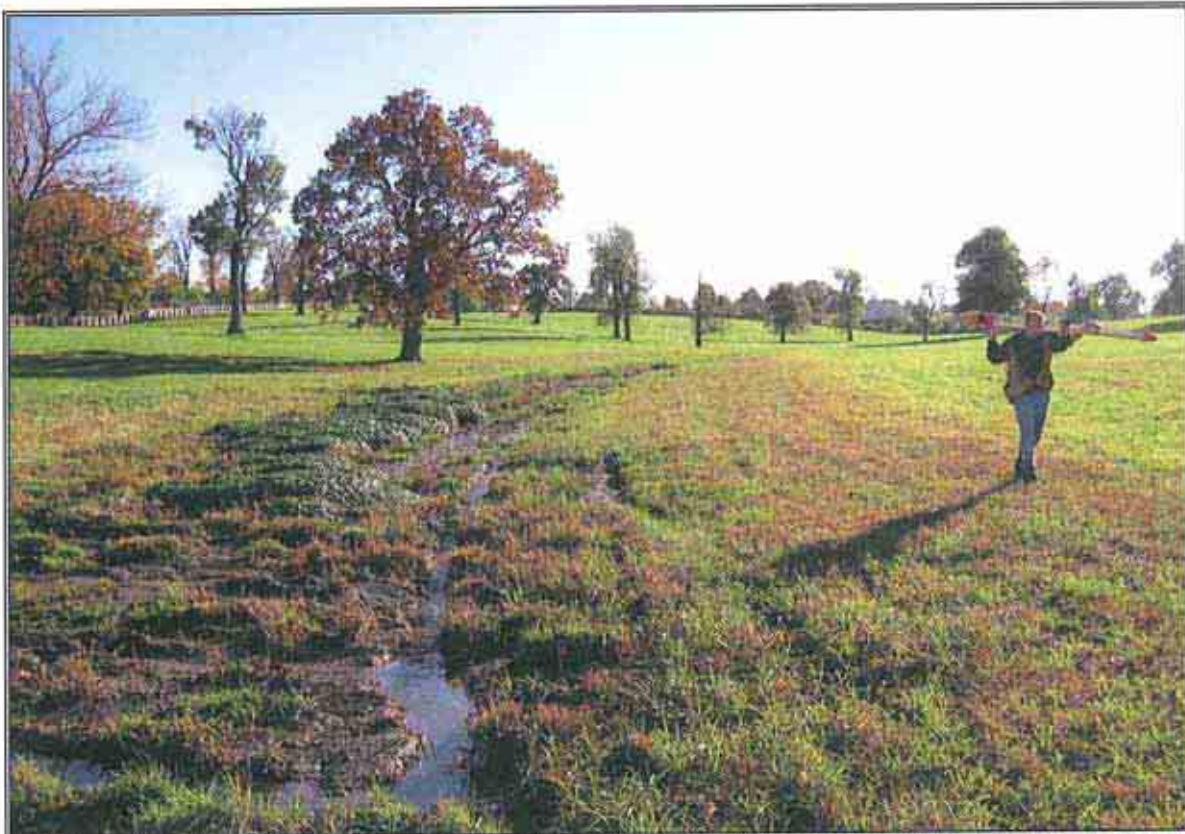
Photograph 1: General view of the restoration area for Stream 3. Padua Stables Project. October 26, 2009.

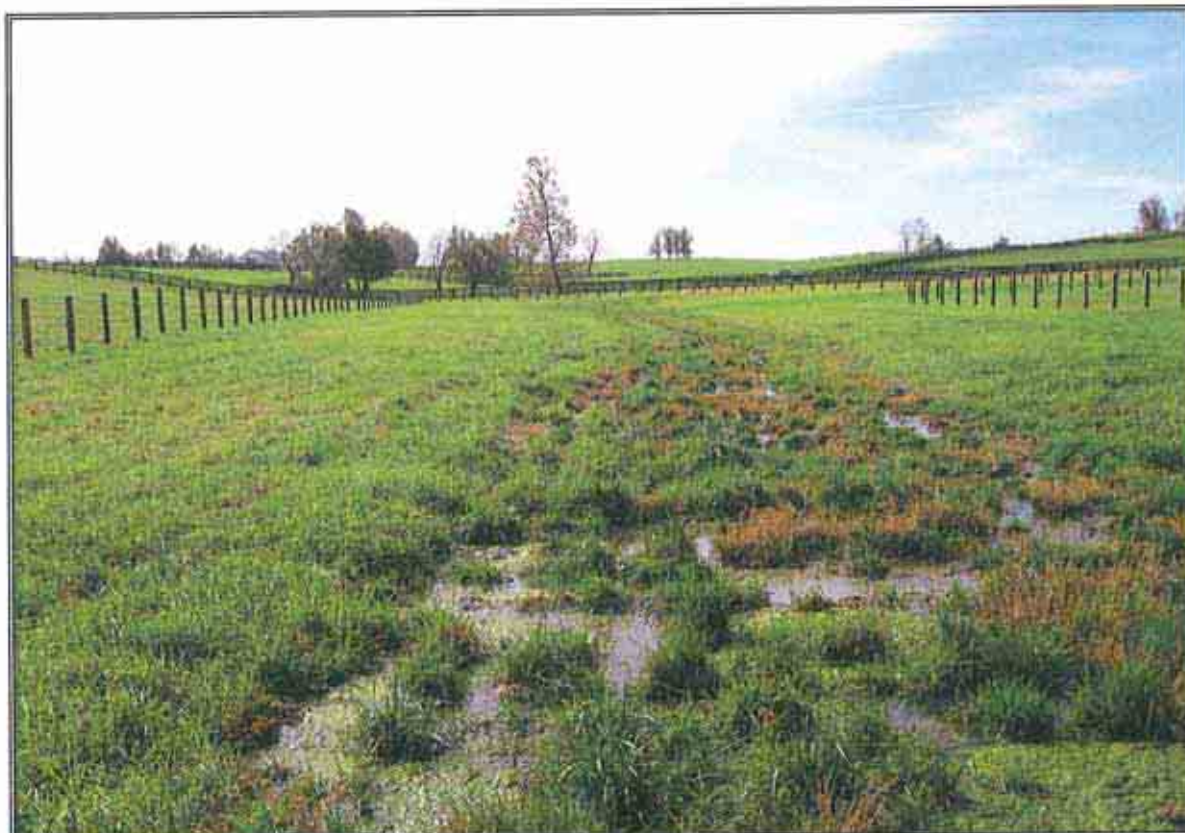
Photograph 2: General view of the restoration area for Stream 2. Padua Stables Project. October 26, 2009.

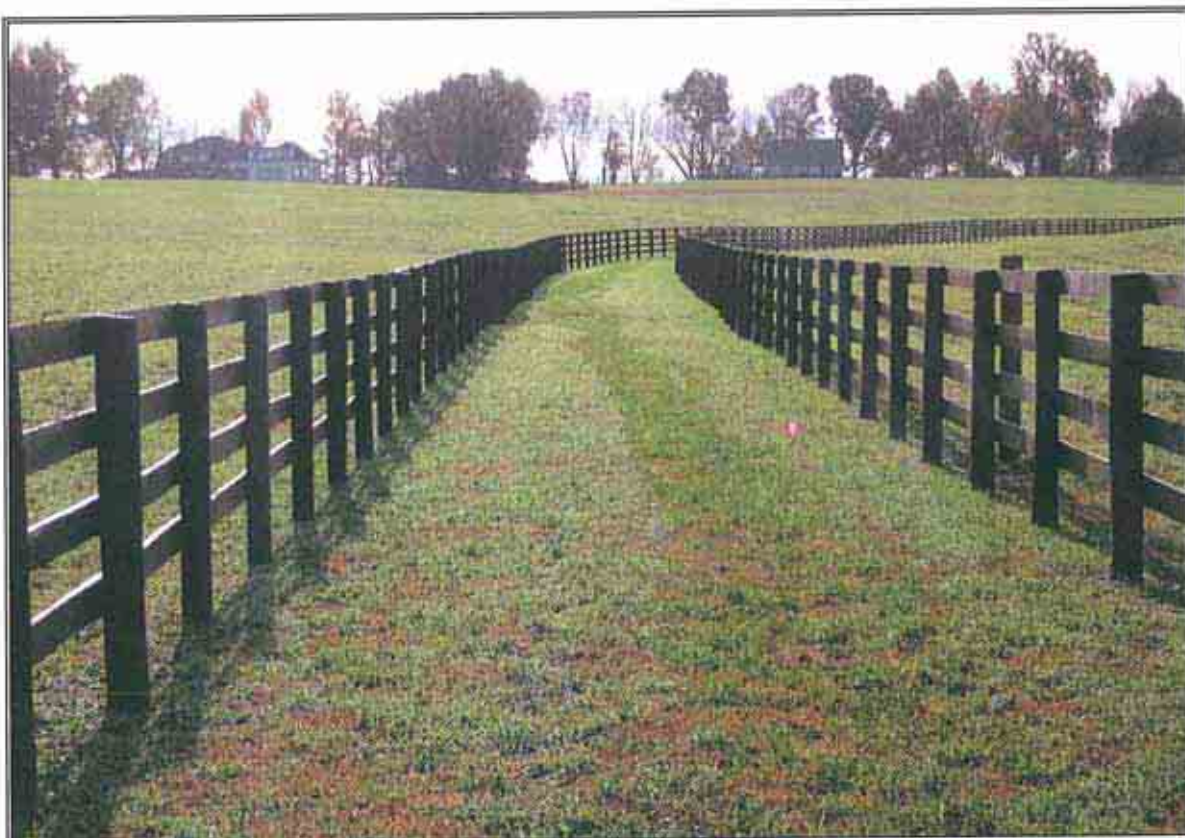
Photograph 3: General view of the restoration area for Stream 4 looking upgradient in the central portion of the restoration area. Padua Stables Project. October 26, 2009.

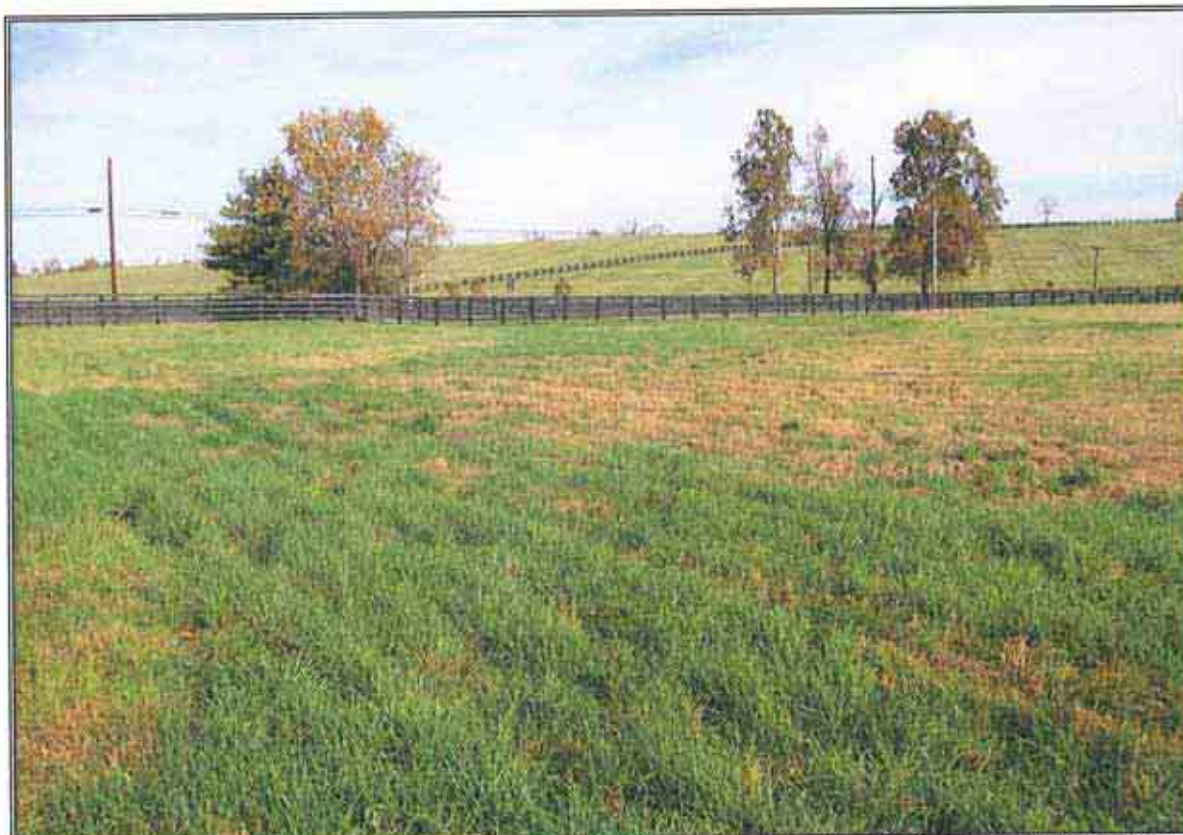
Photograph 4: General view of the restoration area for Stream 5 looking downgradient toward Old Frankfort Pike. Padua Stables Project. October 26, 2009.

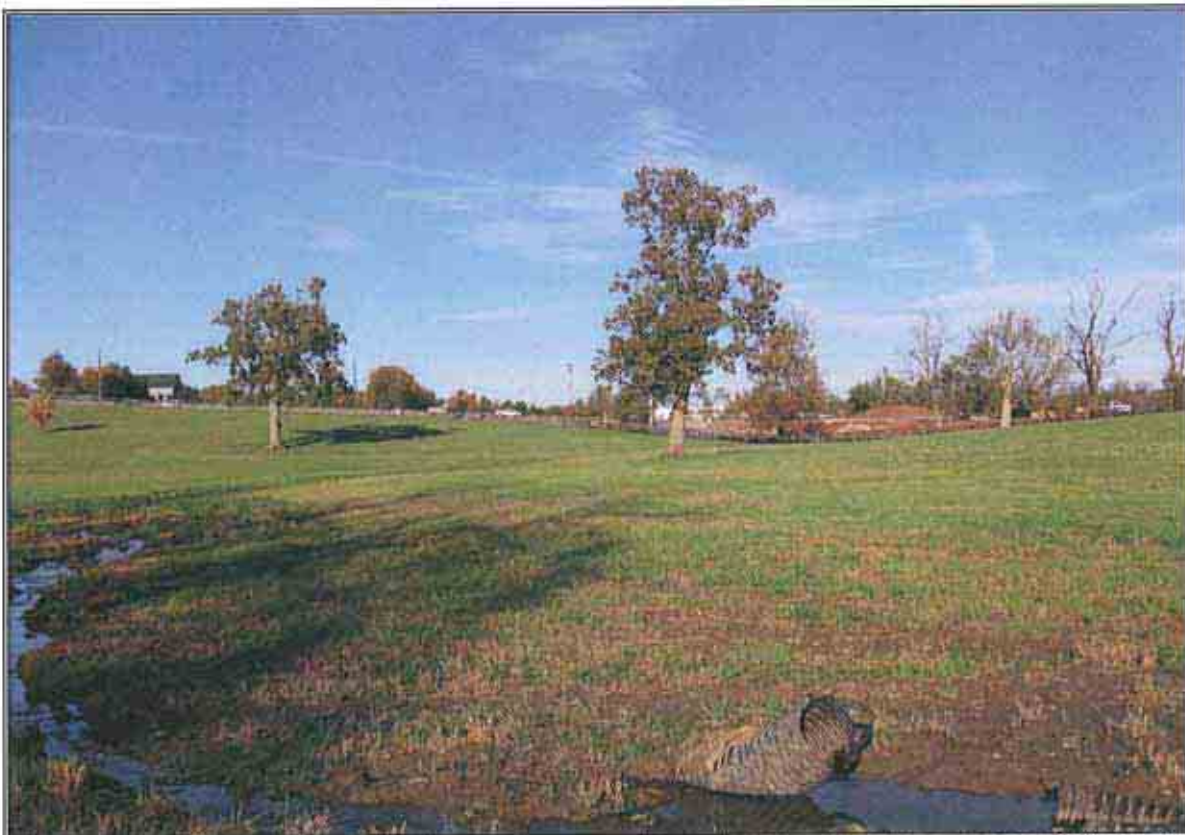
Photograph 5: General view of the stream enhancement area along the downstream portion of Stream 2. Padua Stables Project. October 26, 2009.

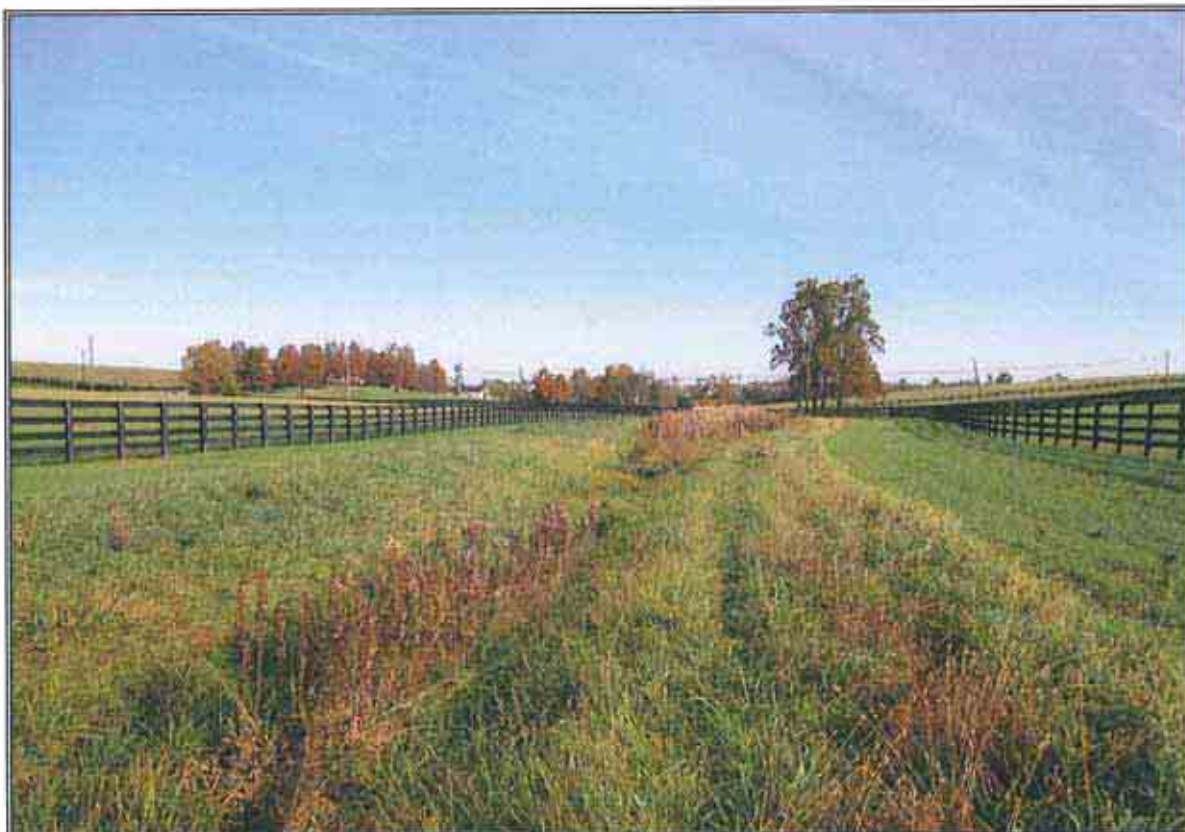
Photograph 6: General view of the stream enhancement area along the downstream portion of Stream 3 looking downgradient toward Old Frankfort Pike. Padua Stables Project. October 26, 2009.
